A New Safety Image

Mick Handcock, Chief Engineer and Maintenance Supervisor, FPSO *Crystal Ocean*

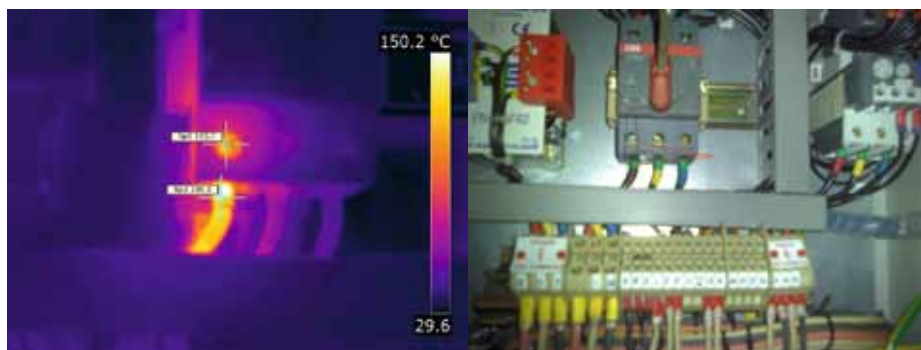
*Comments: Engine Room Port Side
SW Cooling Pump # 1 Main Switch, possible poor connection*

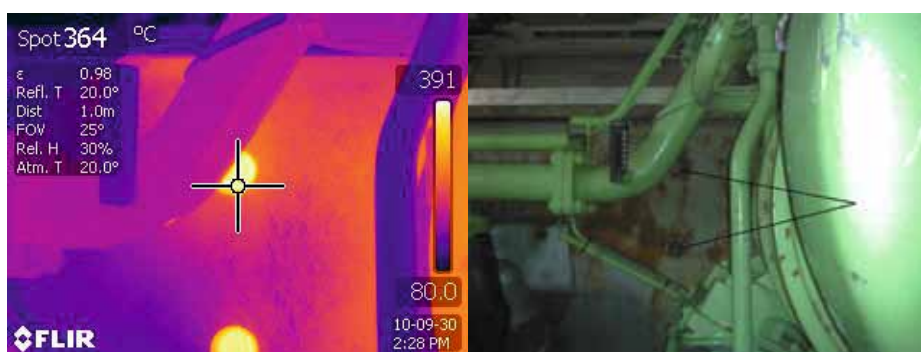
Comments: DG 4, A bank exhaust studs. Exposed or uninsulated exhaust studs, will require capping. This is consistent on all diesel generators.

With reference to the above examples it should be noted that the detected temperatures of

the hot surfaces were above the auto ignition temperature of diesel oil which is 260 °C. The auto ignition temperature is the temperature at which a substance will ignite due to heat and

burn without the presence of a flame. Safety of Life at Sea (SOLAS) regulations also stipulate that surfaces capable of heating above 220 °C be properly insulated.

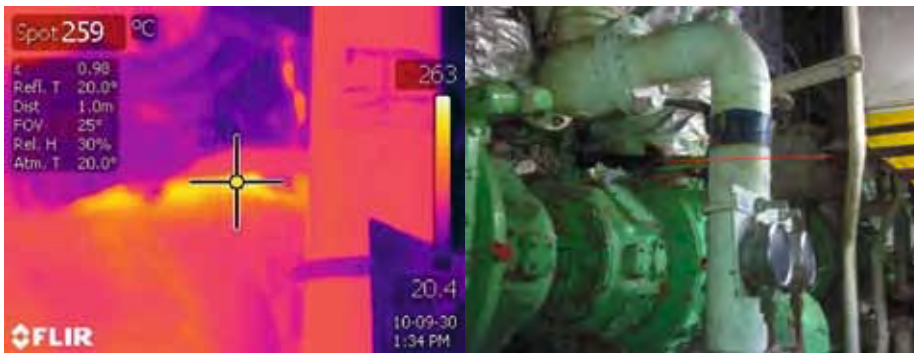
Comments: DG 2 Turbo exhaust outlet B. Damaged, insufficient or obstructed insulation exposing the exhaust. This is consistent with all turbo chargers both at the base and upper turbo exhaust outlets. Inspection of insulation on turbo outlets on all 4 DGs is recommended.
